Microsoft Surface Laptop Teardown

Teardown of the Microsoft Surface Laptop performed on June 15, 2017.

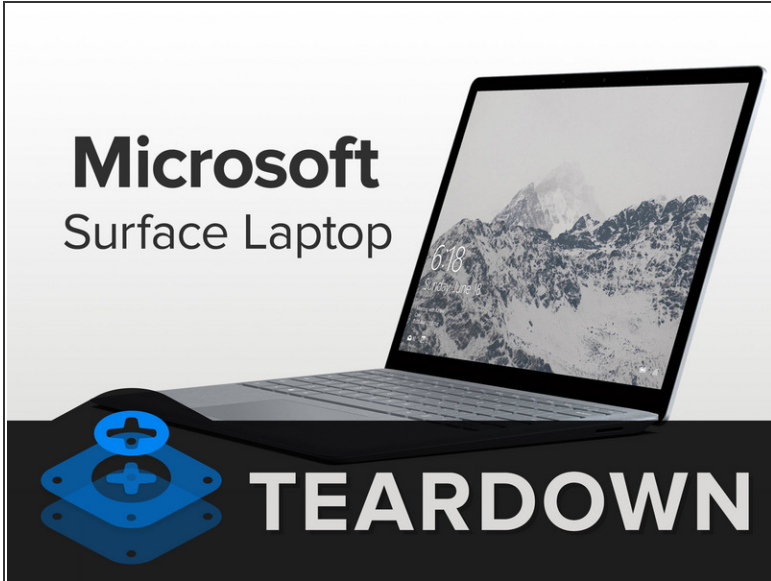
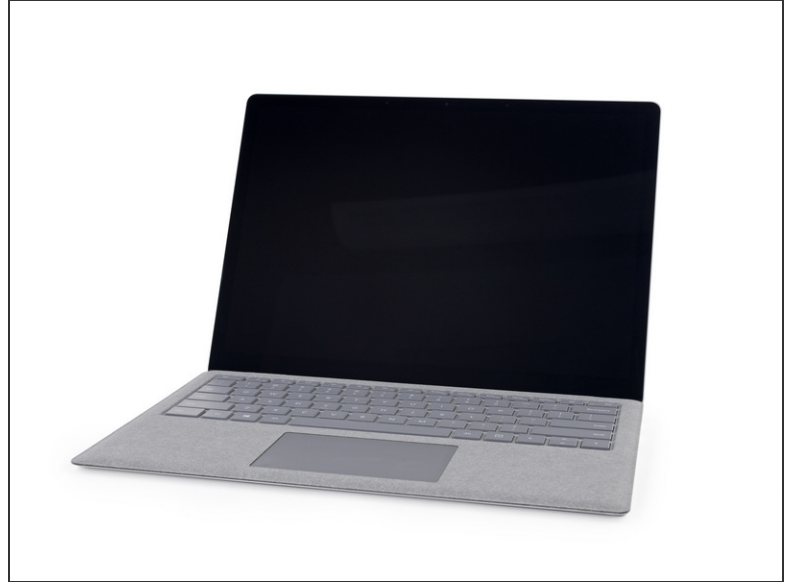
Step 1 — Microsoft Surface Laptop Teardown

- Alright, the Surface Book is out of the box and on our ~~chopping block~~ teardown table. Here's what we're looking to find today:
 - 13.5" IPS PixelSense™ Display with 2256 × 1504 resolution (201 PPI)
 - Intel Kaby Lake Core i5 (3M Cache, up to 3.10 GHz) or Core i7 (4M Cache, 4.00 GHz) CPU
 - 4 GB/8 GB/16 GB RAM
 - 128 GB/256 GB/512 GB PCIe SSD storage
 - 720p front-facing camera with Windows Hello sign-in
 - USB 3.0 port, Mini DisplayPort, and SurfaceConnect charging port
 - 802.11ac Wi-Fi wireless networking, IEEE 802.11 a/b/g/n compatible, Bluetooth Wireless 4.0 technology

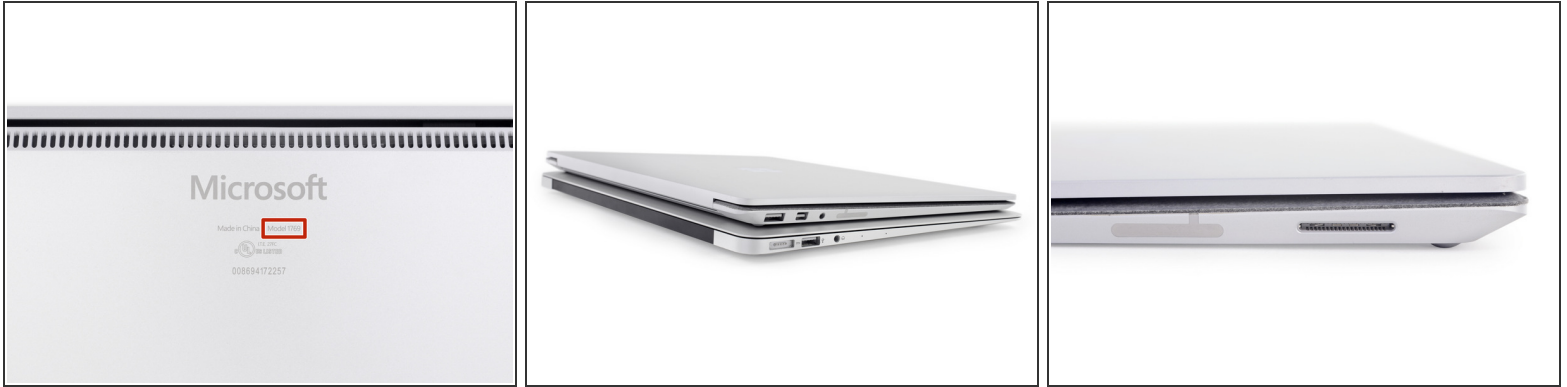
Step 3

- All the usual regulatory markings are hiding out on the lower case alongside the model number: 1769.
- We stack it up (literally) against a MacBook Air to play a game of spot the differences...
 - ... But apart from the layout, there's not a ton. Both sport a headphone jack, proprietary charging port, Mini DisplayPort connector, and at least one USB 3.0 port.
 - Connectivity differences include: an SDXC card reader and a second USB port in the Air.

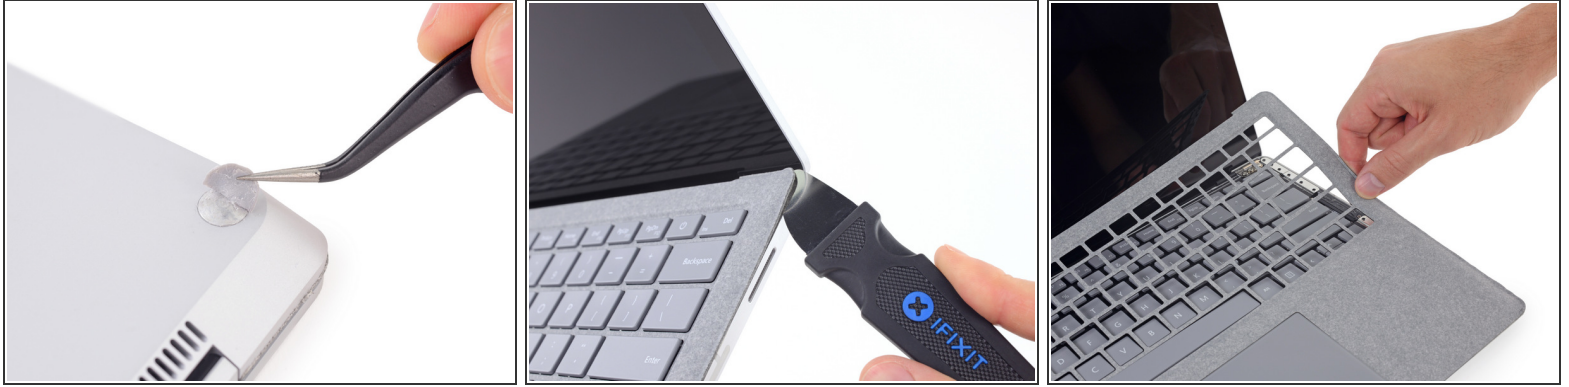
Step 4

- We take a peek under the suspicious rubber footpads, but find metal feet instead of the screws we were hoping for.
- Looks like we have to peel up that ([dubiously luxurious](#)) Alcantara after all.
- [Jimmy](#) in hand, we start popping clips and peeling adhesive. Already, this doesn't feel like it's going back together.
- We try to remove the fabric cover, but the going gets a lot tougher south of the keyboard. What's going on here?

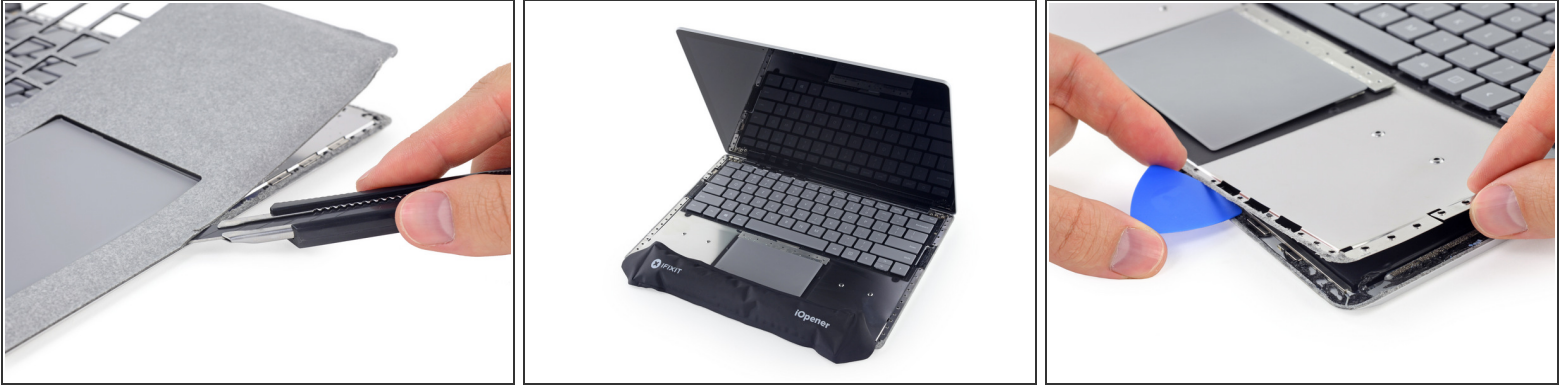
Step 5

- We have to pull out the big ~~guns~~ knife now, to cut off the rest of the pelt. Layered underneath we find a metal shield, the meat in our Surface sandwich.
- With more adhesive and plastic bits holding the shield from beneath, we fire up the iOpener and get back to popping.
- Now that we've got a clear look at the plastic, it seems these aren't reusable clips at all, but weak ultrasonic spot welds that we've been busting through. This is definitely not going back together without a roll of duct tape.

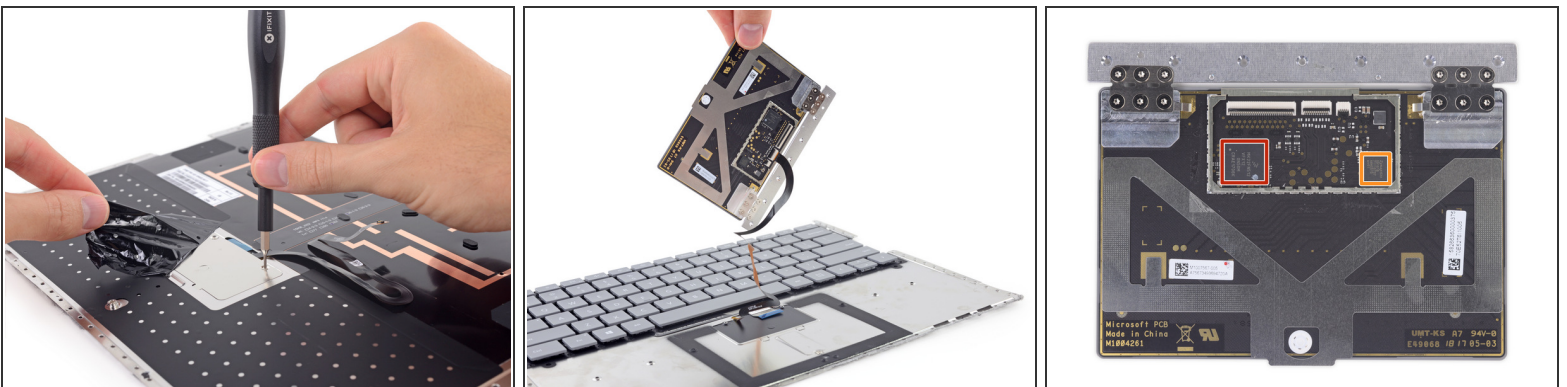
Step 7

- The trackpad is trapped under tape and a metal shield, but it's nothing we haven't handled before.
- We take a moment to check the silicon before releasing this trackpad into the wild:
 - NXP/Freescale [MK22FN512](#) Kinetis K22-120 MHz ARM Cortex-M4 Core MCU
 - Synaptics S9101B touch controller (as seen in the [Surface Book](#))

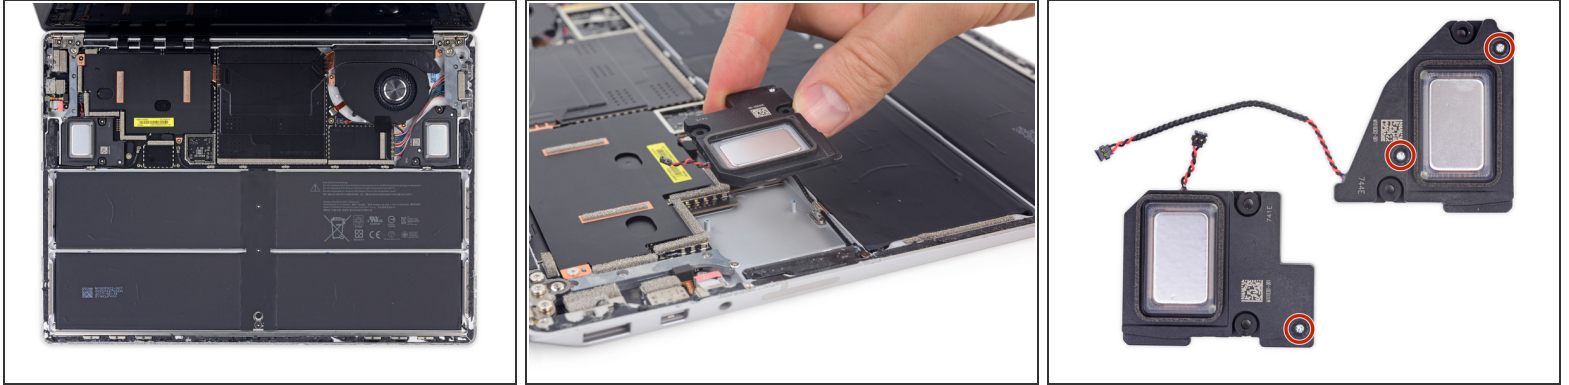
Step 8

- We look around for a battery connector to dispatch, but it's nowhere to be seen. Looks like we're doing this live! Time to start pulling out parts!
- First up, speakers. What is there to say about speakers? They look like they're pretty good at speaking.
 - Like in the [Surface Pro 4](#), they are not exactly symmetrical. Just like in the [Surface Book](#), there are two of them.
- At first glance, these white dots appear to be water damage indicators. Upon [closer inspection](#), they're actually port covers to contain [damping foam](#), increasing the speakers' bass response.

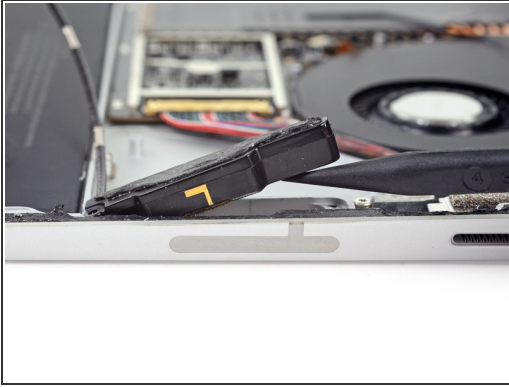
Step 9

- We are unsurprised to find an antenna nestled behind the plastic RF passthrough on the side of the case.
- Turning back to the motherboard, all of the fun bits are hidden under shields packed with thermal pads. Looks like a lot of things get warm in here.
- Oh well guess that means we don't really need the heat sink. Out it comes, [and its little fan, too.](#)

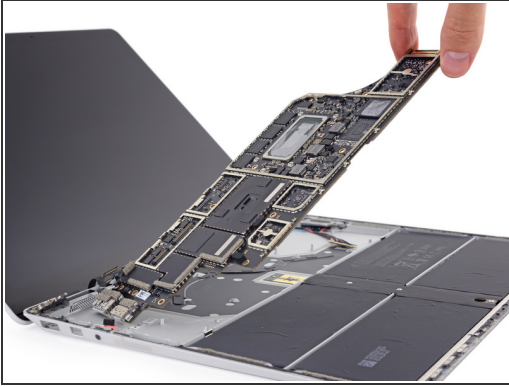
Step 10

- Stop. Motherboard time!
- Intel [SR368](#) Core i7-7660U CPU
- SK Hynix [H9CCNNNBJTAL](#) LPDDR3 RAM
- Toshiba THNSND256GTYA 256 GB SSD
- Marvell Avastar [88W8897](#) WLAN/BT/NFC SoC
- Microsoft X904169 (x3) and X904163 display driver ICs
- Nuvoton [NPCT650SBBWX](#) TPM IC
- Freescale/NXP [M22J9VDC](#) Kinetis K22F 512KB 120 MHz ARM Cortex-M4 Based MCU

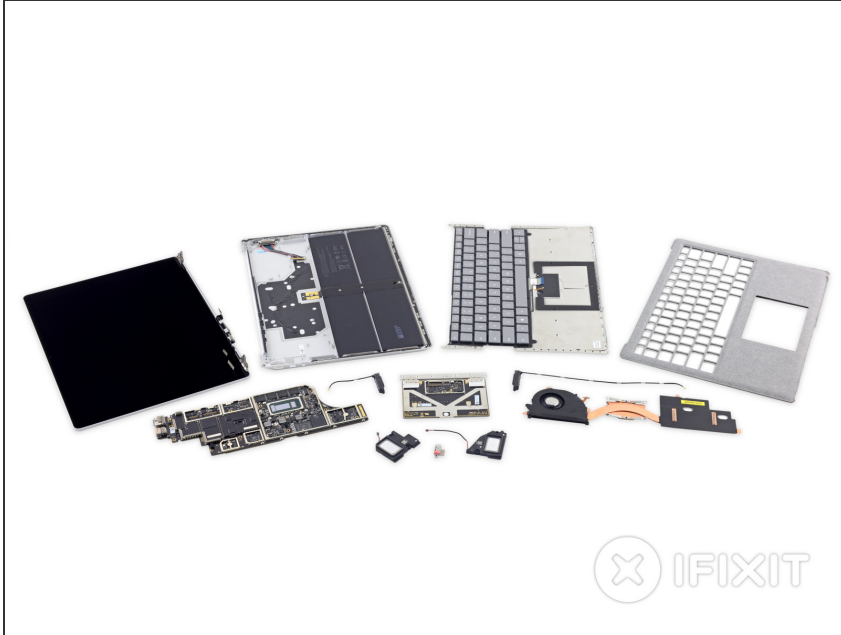
Step 12

- The Surface Laptop is finally ~~vanquished~~ disassembled!
- Verdict: The Surface Laptop is not a laptop. It's a glue-filled monstrosity. There is nothing about it that is upgradable or long-lasting, and it literally can't be opened without destroying it. (Show us the procedure, Microsoft, we'd love to be wrong.)
- Here for your viewing pleasure: the parts that will never be whole again...
- For more teardown below the Surface, check out the [2017 Surface Pro](#) teardown!
